**Hoo Station GRIP 3 – Reopening of
the Grain Branch Line for Passenger
Services**

Water Vole Survey Report

Report Ref: 103223-PEL-G3-H01-REP-EVV-0006

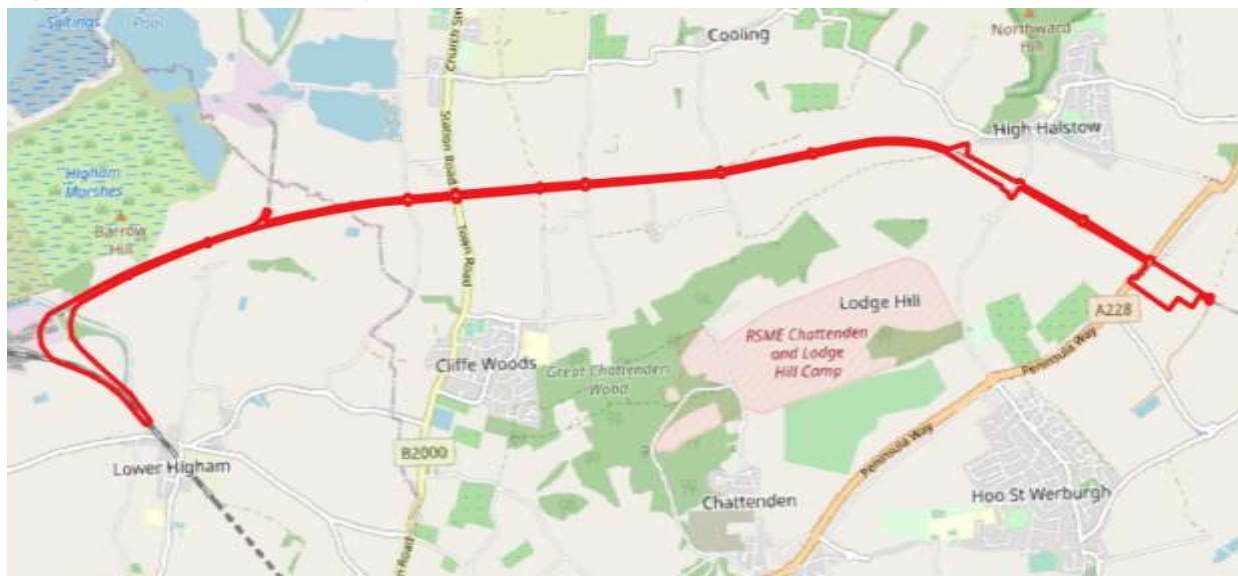
Figure 1 Site Red Line Boundary

The Site included the existing railway known as the Grain Branch and runs from National grid Reference TQ 70493 73859 at Canal Street to TQ 79295 73975 to the south of Sharnal Street.

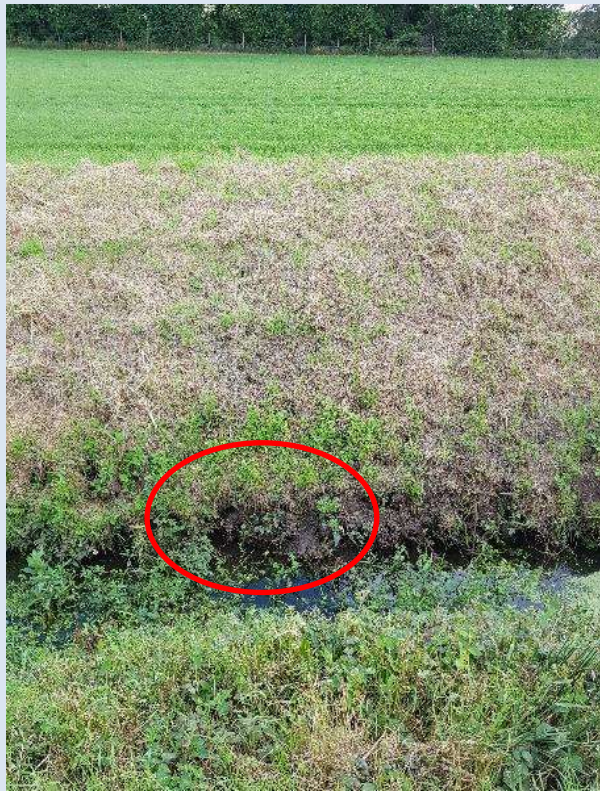
Water vole burrows and latrines were identified within wet ditches to the west of Ratcliffe Highway at approximate grid reference TQ 78608 74366 and referenced WV-RCH1 on the map shown in Appendix A.

Signs of water voles were identified within wet ditches to the south of the railway west of Ratcliffe Highway in June 2019 (ref WV-RCH1)

- Avoid the requirement to culvert any watercourses during construction. In the event that culverts must be installed, they should be as minimum in length as possible and details should be discussed with an ecologist throughout the design process.
- Pre-commencement checks – a suitably qualified ecologist should complete checks of all wet ditches within the construction footprint once this has been finalised and prior to works commencing. This will include surveying for sign of any additional water vole burrows, latrines or feeding stations.

- Habitat manipulation (up to 50m in length) – An ecological clerk of works must be present throughout bankside habitat manipulation. In the event that a water vole burrow, latrine or feeding station is identified within the construction footprint during the pre-commencement checks, all works must stop immediately, and an ecologist consulted. A licenced ecologist may then use habitat manipulation to encourage water voles to move further from the scheme. **This must be carried out by an ecologist with the suitable Class License and can only be completed between 15th February to 15th April inclusive. This method can be used for a maximum of up to 50m of continuous vegetation clearance.**

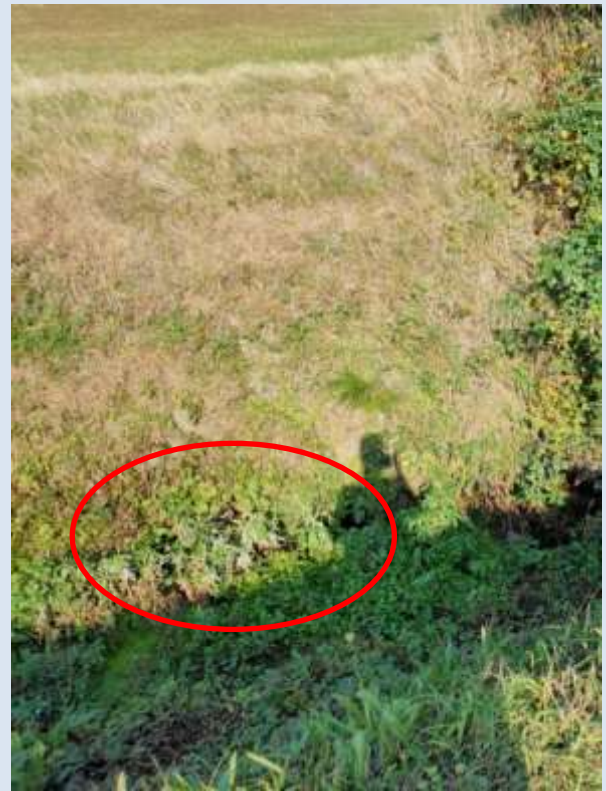
The water vole burrow previously identified in the ditch adjacent to the Ratcliffe Highway was visible during the autumn survey and droppings were also identified in proximity to the burrow

Confirmation of presence of water burrows previously identified in 2019 (ref WV-RCH1)

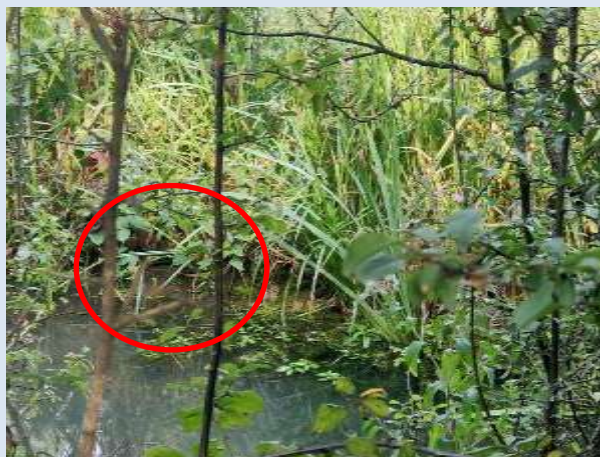
A potential water vole burrow was identified within the wet ditch alongside Canal Road as well as water vole droppings at approximate grid reference TQ7074873824 (ref WV-CR1).

Water vole dropping alongside Canal Road (ref WV-CR1)

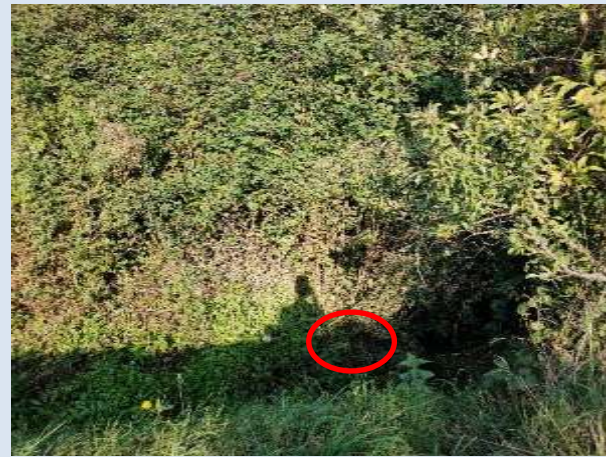
(grid reference TQ 78608 74366). An additional burrow and droppings were identified at approximate grid reference TQ7869274330 (ref WV-RCH2). Discussion with the landowner also provided anecdotal evidence that water voles are present within the ditch leading to the farm and have been observed previously.

Potential water vole burrow and droppings (ref WV-RCH2)
